Field Report for Airborne Data Collected In Support of US EPA Region 6 Intercontinental Terminals Company LLC Fire 31 March 2019

Data Results Flight 16, 31 March 2019

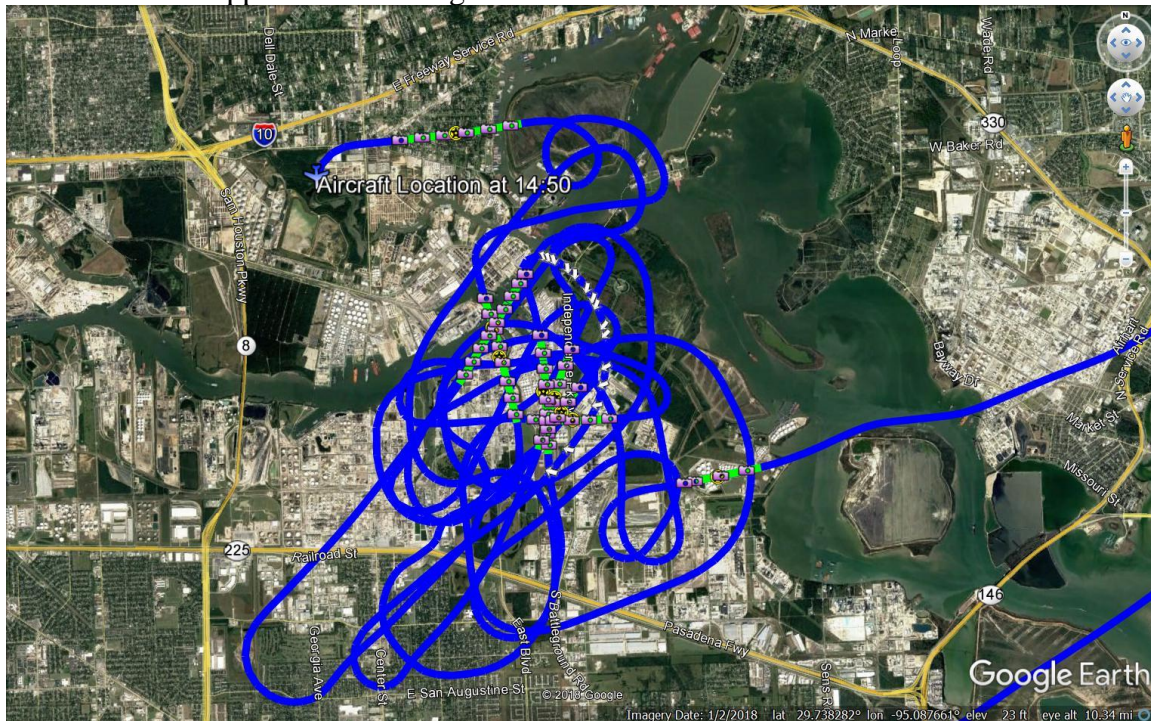
Figure 2: Flight line data for 31 March 2019, Flight 16. The blue lines represent the ASPECT flight path, green lines represent when the Infrared Line Scanner was actively collecting data, and the camera icons represent when a photo was taken.

The order to launch the aircraft was given at 0835 local on 31 March 2019 and the aircraft was airborne at 0840. The initial data collection run over the site was at 0901 (local) and the aircraft made a total of 7 data collection passes. Flight information is summarized in Appendix A and Figure 2.

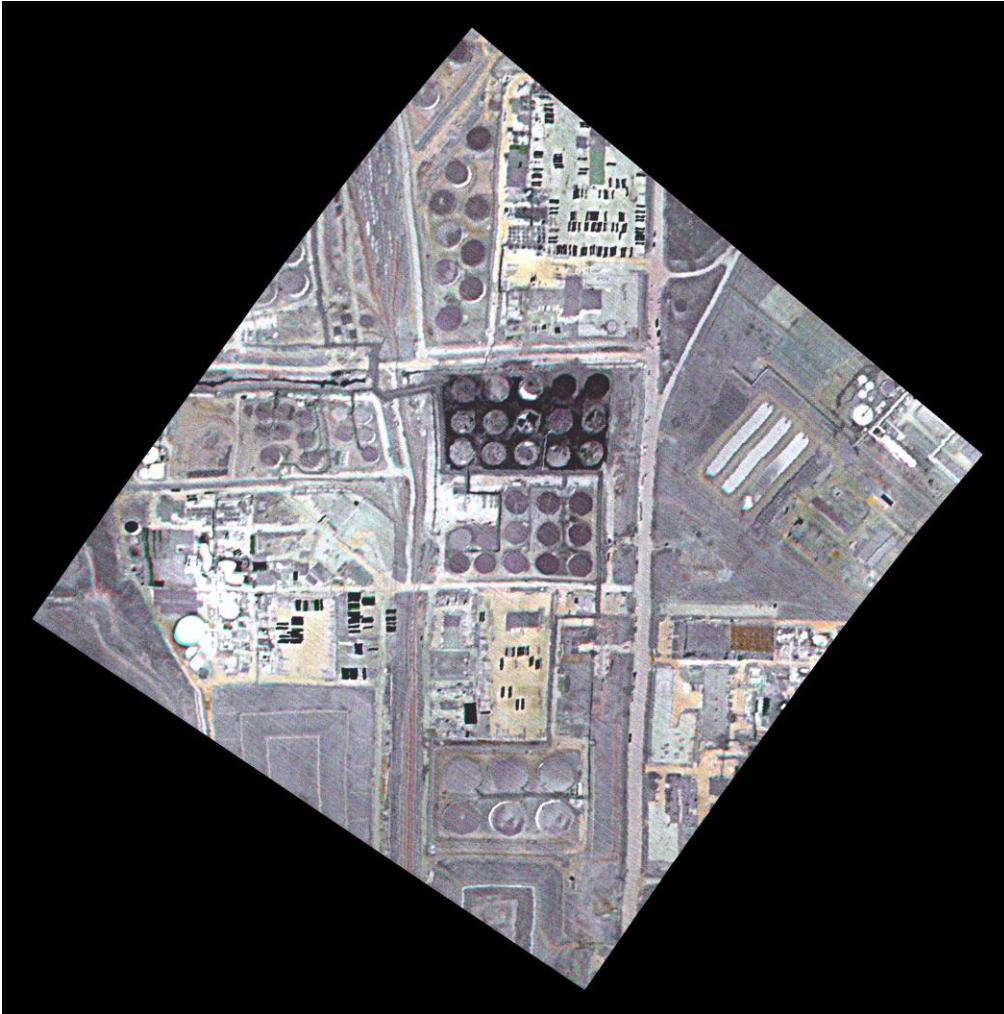
A total of 1 test and 7 data passes were made in the proximity of the impacted tank farm and also in extended areas surrounding the site and infrared line scanner images were generated for each pass. Figure 3 shows a typical 3-band infrared image obtained from data collected for Run 3. IR imagery of the tank farm indicates that all tanks are at ambient temperature with tanks in the NE corner of the farm being the coolest. A thermal image of the tank farm for the same pass confirms this observation.

Figure 3: IR image of ITC data for 31 March 2019, Flight 16 Run 4

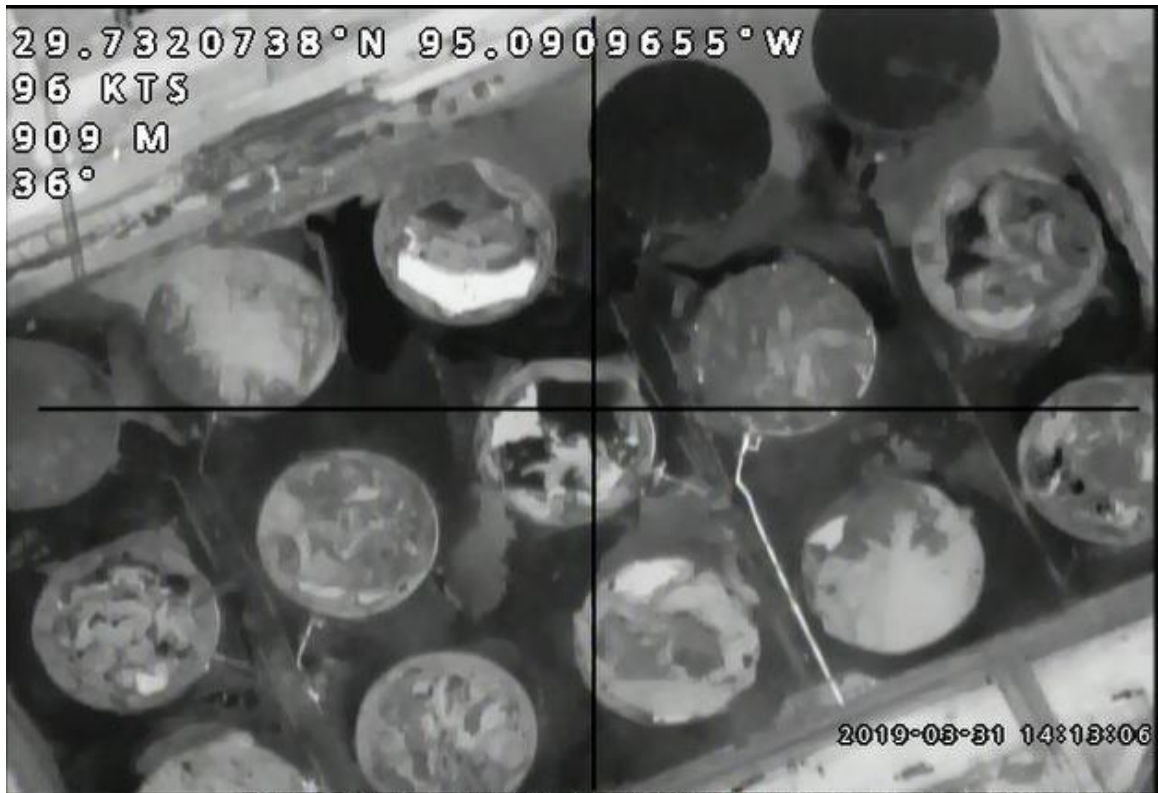
Figure 4: IR Thermal Analysis 31 March 2019, Flight 16, Run 4

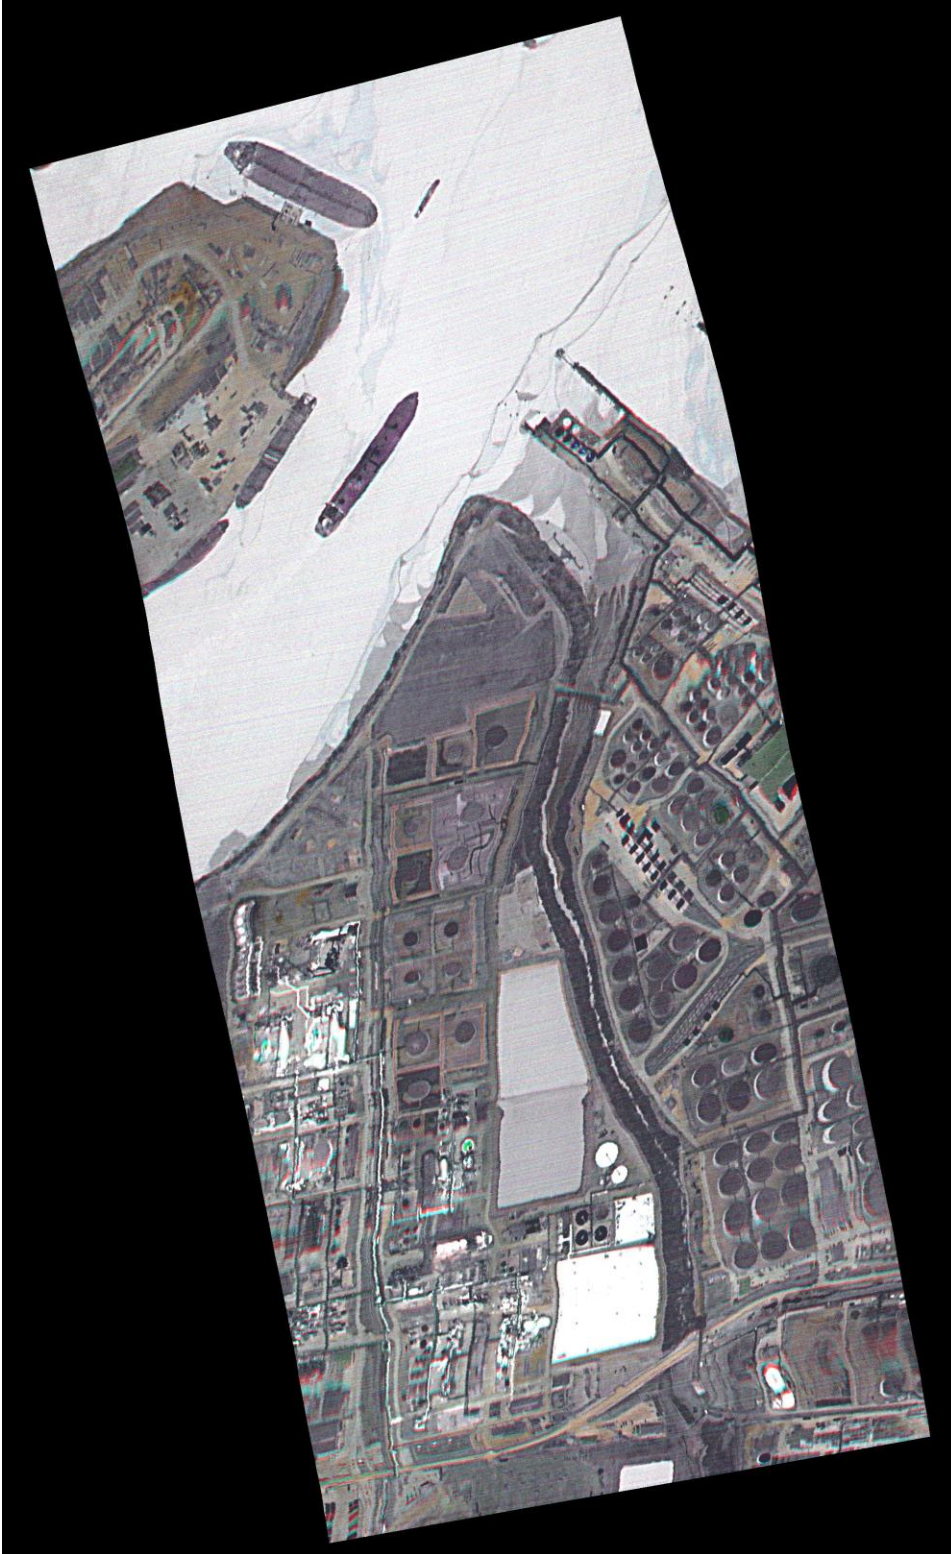
An IR image of the confluence area is given in Figure 5. Boomed oil can be seen being pushed to the south due to the winds. A small amount of product can be seen on the outside of the ship channel boom, largely pushed up against boom structure. In addition, some sheen is present in the channel north of the booms and along the opposite shore.

Figure 5: IR Image of Contained Oil 31 March 2019, Fight 16, Run 7

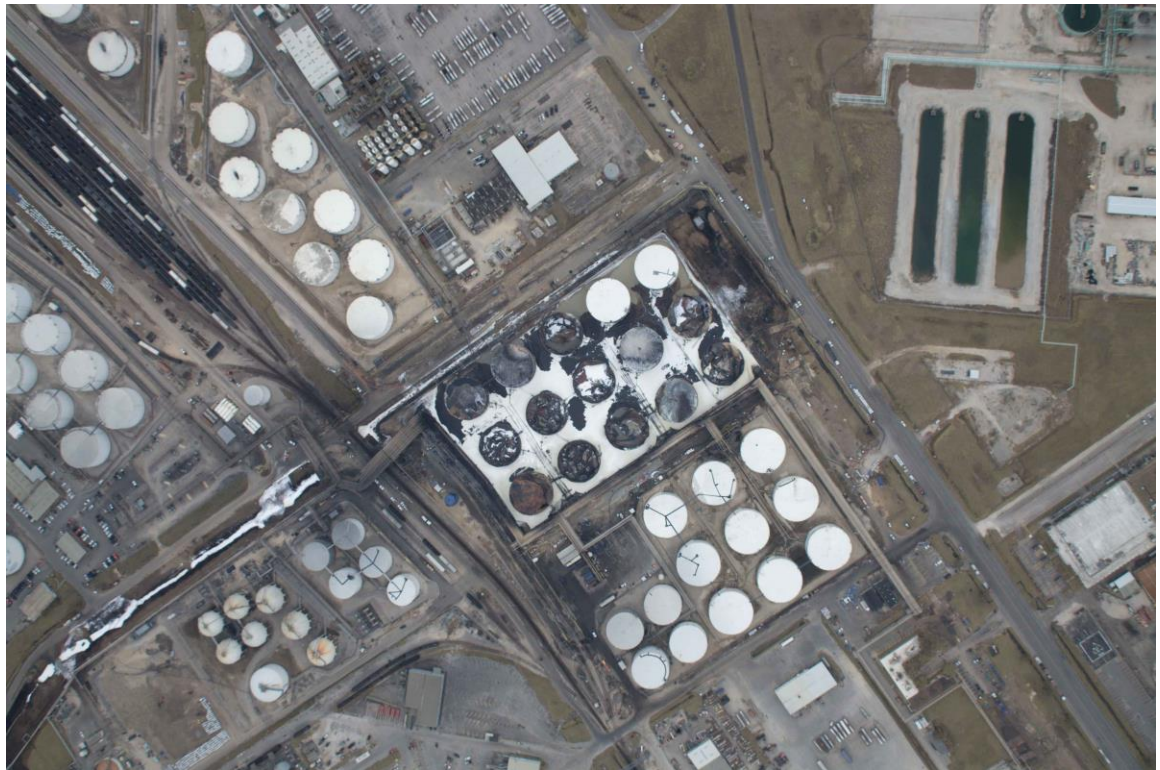
A full set of high resolution aerial digital photography was collected as part of the flight. Figure 6 shows a representative overhead image collected as part of each pass over the tank farm. Analysis of the image shows that several of the tanks appear to have the tops removed. An oblique image of the tank farm confirms that 6 of the tanks appear to have the tops and sides removed.

Figure 6: Aerial Image of the Tank Farm, 31 March 2019, Flight 16

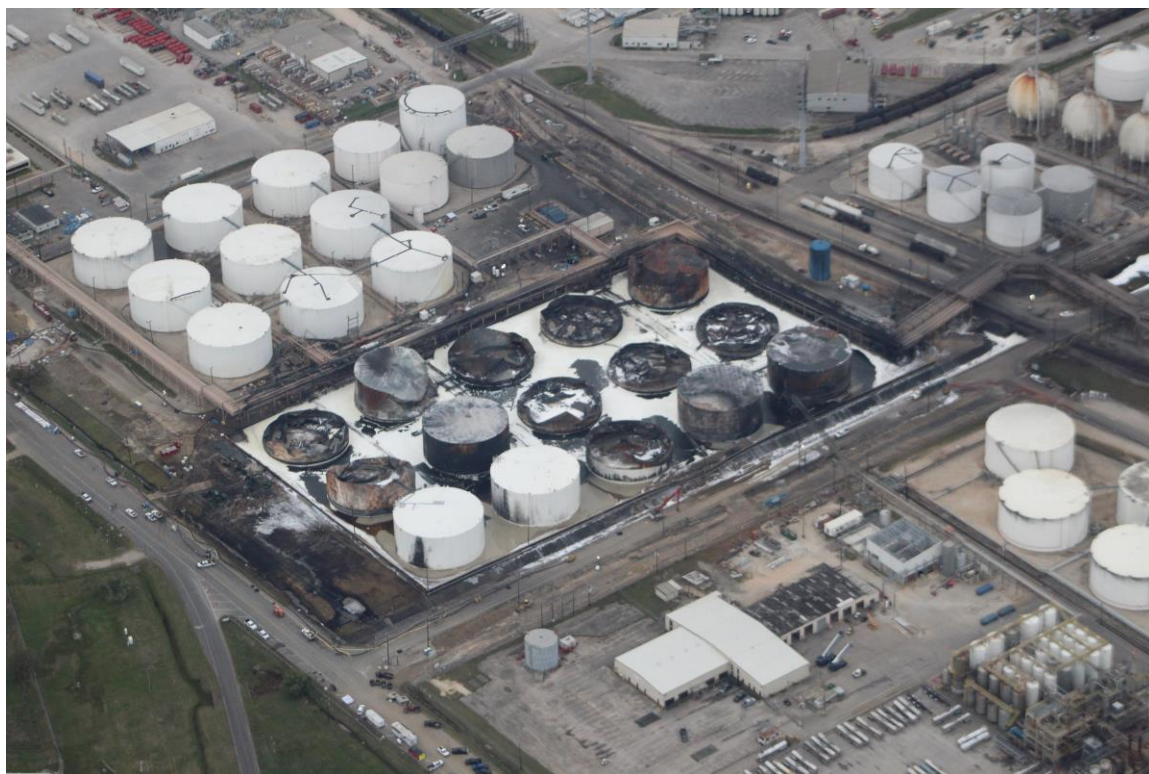
Figure 7: Oblique Image of the Tank Farm, 31 March 2019 Flight 16

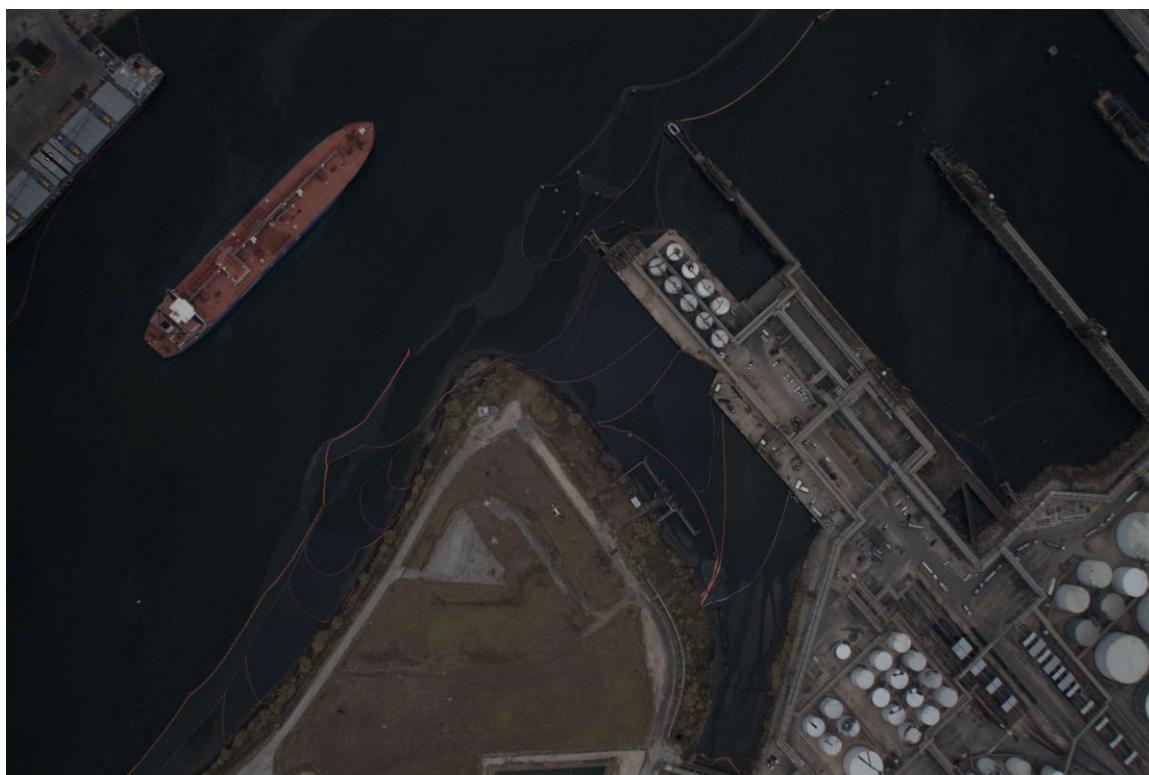
An aerial image of the confluence area is shown in Figure 7. Note that the image is darker due to high level cloud cover. Numerous booms can be seen in the confluence area with trapped product in each boom pocket. A small amount of sheen can be seen in the lower left area of the ship channel boom. An oblique of the same area confirms the presence of trapped material in the boom structure with sheen pushed up against the ship channel booms by the wind (Figure 8).

Figure 7: Aerial Image of the Ship Channel Boom Area, 31 March 2019, Flight 16

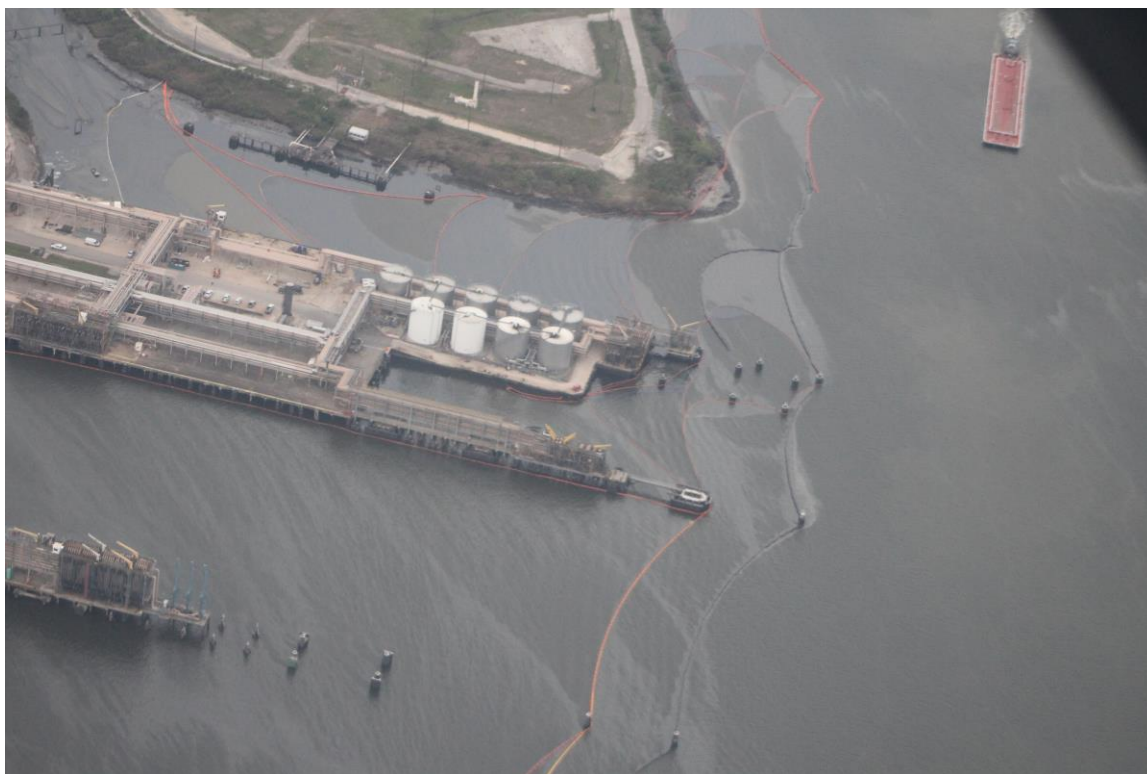
Figure 8: Oblique Image of the Ship Channel Boom Area, 31 March 2019, Flight 16
